NH Horticultural Endowment 2012 Annual Report

NEW HAMPSHIRE PLANT GROWERS ASSOCIATION
Horticulture Endowment Fund
Progress Report December 31, 2012

1. **Project title:** *Novel Methods for Energy Conservation in Northern New England Greenhouses*
2. **Principle Investigator's name:** Dr. Margaret Skinner, Research Professor
3. **Name and address of affiliated institution:** University of Vermont, Entomology Research Laboratory, 661 Spear Street, Burlington, VT 05405-0105
4. **Phone number:** (802) 656-5440
5. **Fax number:** (802) 656-5441
6. **Email address:** miskinner@uvm.edu
7. **Progress Report:**

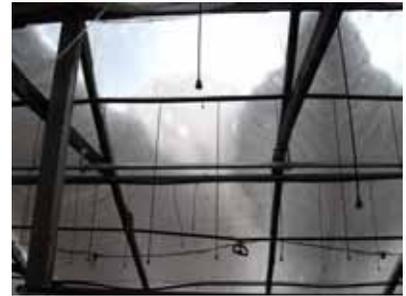
Fig. 1. Bubble system in operation, filling the void with soap bubbles.

Funding from the New Hampshire Plant Growers Association, Horticulture Endowment Fund was received to support research to refine and improve on the design of a novel energy conservation system using soap bubbles to insulate a plastic-covered gable/hoop style greenhouse. This is a unique device that generates soap bubbles to fill the space between the two layers of plastic covering the house (Fig. 1). Energy efficiency for this novel system is being compared with a thermal energy curtain (Fig. 2) and an unimproved greenhouse. These systems were installed in October 2010 in separate greenhouses at a commercial operation in Vermont. Monitoring of various environmental and energy use factors is underway to measure the effectiveness of both systems under real-world conditions. The bubble insulation system is not an off-the-shelf product and has been somewhat challenging to put into operation. It was necessary to adapt it for use in the test greenhouse.

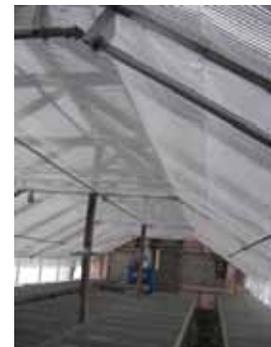
Fig. 2. Thermal curtain after installation.

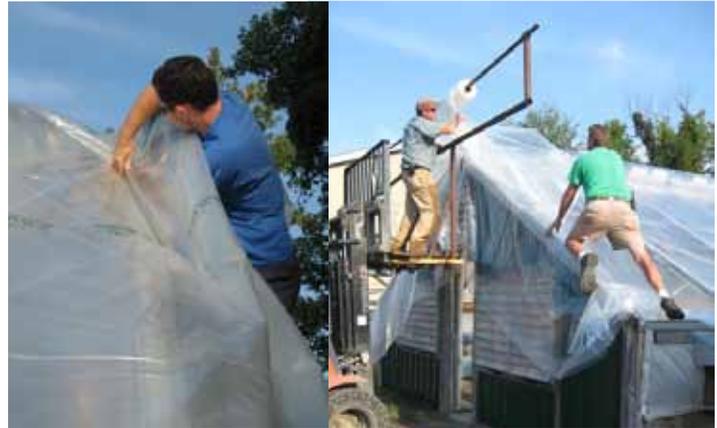
Fig. 3. Replacing plastic on bubble system greenhouse; Canadian expert installing splines (left); UVM and Claussen employees rolling out plastic (right).

Several unforeseen issues associated with the bubble insulation system surfaced this autumn (2012) that required our immediate attention to get the system back in operation. First, it was critical to replace the plastic covering the bubble greenhouse to reduce soap solution leaks due to small tears that occurred over the last year. We enlisted a specialist from Canada, who worked previously on this system, to help with putting the plastic on to ensure it was done correctly (Fig. 3). As a result of his expert assistance, we learned the importance of the degree of tightness of

the plastic necessary. This eliminated a past problem we have had to keep the two layers of plastic inflated when the system is not in operation. It also reduced the volume that must be filled with soap bubbles when the system is operating, which minimizes leakage and shortens the time required to fill the system.

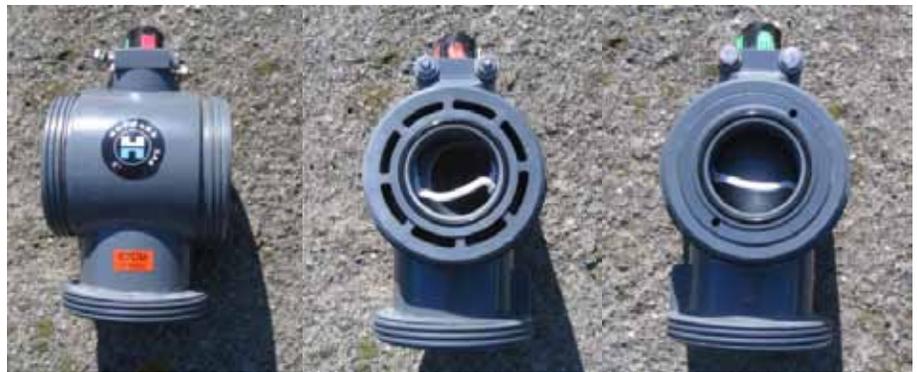
Fig. 4. Hayward valve that failed due to high heat.

The second issue that arose was mechanical. We discovered that at the height of the hot spell during the summer, the exhaust fans in the greenhouse were accidentally turned off. The heat inside the greenhouse reached over 150° F. When we started the system in September, it didn't work. After a detailed evaluation of the system components, we discovered that the high internal temperature in the greenhouse resulted in damage to the O-ring within a critical valve (Fig. 4). This valve was replaced and the system again is operating properly.

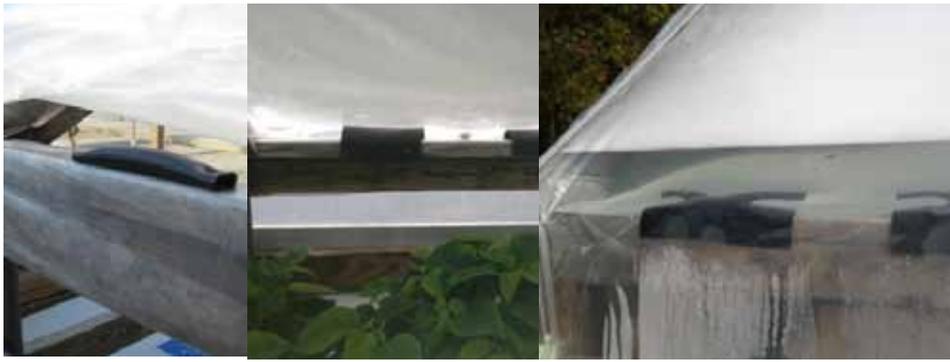
Fig. 5. Device for preventing fluid pooling at the edge of the greenhouse (left to right); black tube attached to hip frame of greenhouse, EPDM plastic covering tube; pooling of the soap solution that continued to occur.

The third issue we dealt with arose as a result of replacing the plastic. Because an effort was made to attach the plastic tighter over the frame, the soap solution tended to pool at the hip of the greenhouse, rather than draining back to the tank. This reduced the efficiency of the soap solution and increased the chance of leaks. In previous years we had placed a foam separator between the two layers of plastic that was attached with a screw through the bottom layer of plastic. This resulted in leaks which could not be stopped. Therefore it was essential to design a system that did not require attachment through the plastic. Several approaches to address this issue were devised. The first approach was to attach a black tube to the greenhouse frame below both layers of plastic. To prevent tearing of the plastic, we attached a layer of EPDM plastic over the tube (Fig. 5). Though this did allow some drainage to occur, when the system was in full operation, fluid continued to pool up. We next devised a tube system using pieces of black tubing placed vertically along the hip of the greenhouse between the two layers of plastic. These were designed to allow a channel for the fluid to move across the hip frame (Fig. 6.). The tubes are not attached to the wooden frame, but are held in place by the tension from the plastic. To date this device appears to have eliminated the problem. Because they sometimes become dislodged if there are heavy winds, a notch has been cut in the middle of the tubes so they remain in place.

Therefore it was essential to design a system that did not require attachment through the plastic. Several approaches to address this issue were devised. The first approach was to attach a black tube to the greenhouse frame below both layers of plastic. To prevent tearing of the plastic, we attached a layer of EPDM plastic over the tube (Fig. 5). Though this did allow some drainage to occur, when the system was in full operation, fluid continued to pool up. We next devised a tube system using pieces of black tubing placed vertically along the hip of the greenhouse between the two layers of plastic. These were designed to allow a channel for the fluid to move across the hip frame (Fig. 6.). The tubes are not attached to the wooden frame, but are held in place by the tension from the plastic. To date this device appears to have eliminated the problem. Because they sometimes become dislodged if there are heavy winds, a notch has been cut in the middle of the tubes so they remain in place.

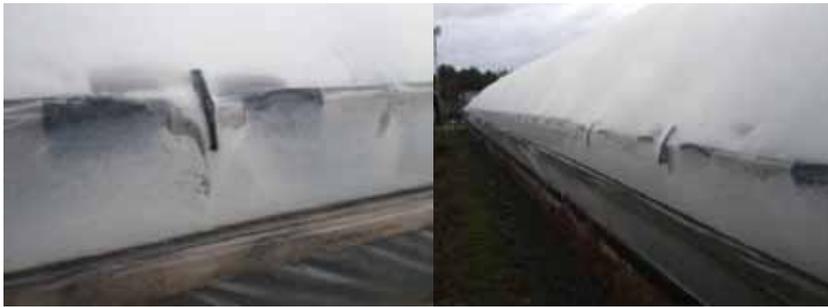
Fig. 6. Black tubing placed vertically between the two layers of plastic, which effectively eliminated the pooling problem.

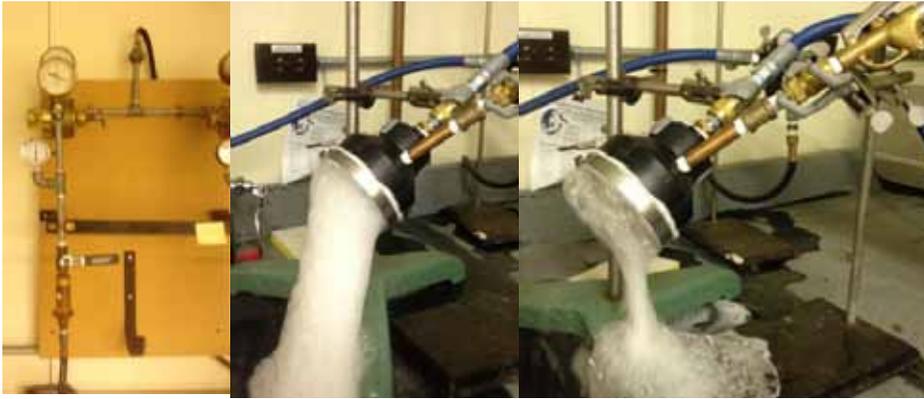
Fig. 7. Apparatus to test the quality of soap bubbles at different Carbowax concentrations (left to right), gauges allowing us to control pressure; good quality bubbles produced with a 2% soap and 10% Carbowax solution; poor quality bubbles produced with a 2% soap and 40% Carbowax solution.

The fourth problem we encountered was linked with the soap bubble solution. In previous years we had used solution donated by the company. It was a slightly different formulation, but it was more cost effective in the experimental stage to use up this material. This fall we prepared fresh solution using the new formulation. This included adding Carbowax, a substance that serves as an antifreeze. The suggested concentration for Carbowax was 10%, which provided freeze protection to 26° F. Given the cold temperatures that occur in Vermont, we increased the concentration to 40% to provide protection to -5° F. We were alarmed to observe that the Carbowax significantly altered the quality of the bubbles produced. Bubbles made from the soap solution with a high concentration of Carbowax were very runny and degraded quickly. This was surprising to us given that we had been told that Carbowax improved the quality of the bubbles. A special apparatus was devised to allow us to test different soap mixtures in the laboratory at a range of pressures (Fig. 7). We ran a series of tests with different Carbowax concentrations and found that the standard 2% soap solution with no Carbowax produced the best suds, i.e., bubbles of small diameter making a dense white stream. The 2% soap with 40% Carbowax, which would provide protection to -5°F produced large-diameter bubbles that came out in a loose watery stream. A 2% soap solution with 10% Carbowax, which provides protection to 26°F, proved to be the best. The bubbles were of a small diameter, and produced a dense stream of suds. After further discussion with the Canadian experts, we learned that even if some freezing of the solution occurs, it will not harm the plastic, and will melt quickly at day break with exposure to the sun.
